Lathe crash: releasing a "stuck" chuck on a Myford Super 7

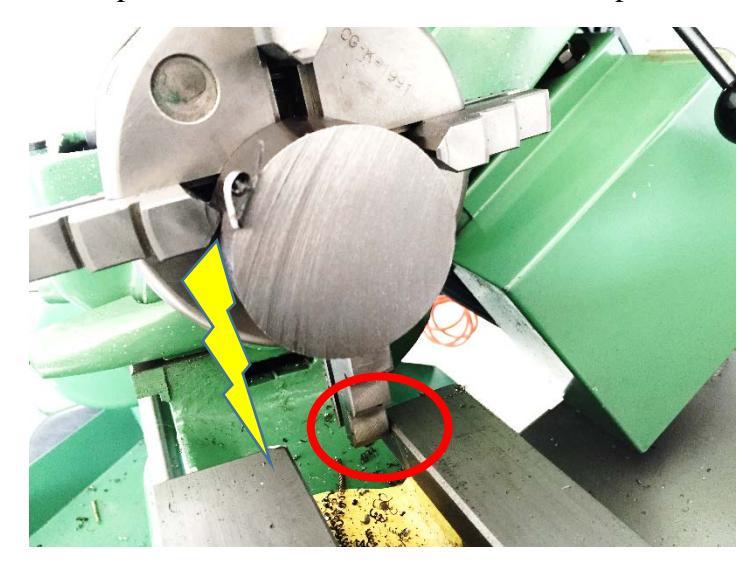
Figure 8: one of jaws hits the bedways (symbolic "fake" picture only taken afterwards)

So it came like you expect: due to the force of the high rotating speed of the chuck, the 4th jaw slipped out during full speed. It fall exactly between the chuck and the metal bedways of my lathe. I heard (and felt!) a big CRASH, the spindle was hardly blocked and stand still within milliseconds by this jammed 4th jaw.

I immediately pushed the knob of the "emergency-off-system" that I have installed in my new workshop, but for sure this was too late to prevent this accident. The 4th jaw left a big dent in the bedways.

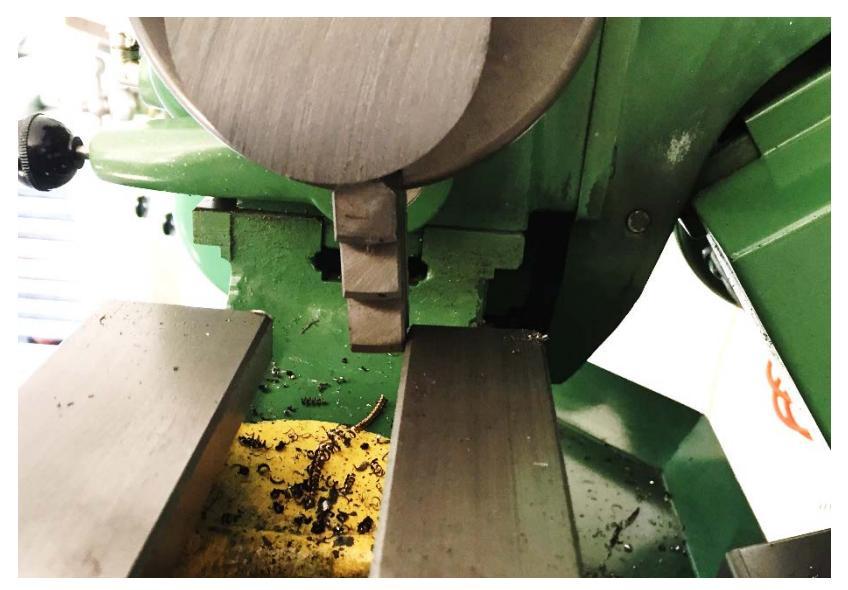
Figure 9: a nightmare for every machinist...

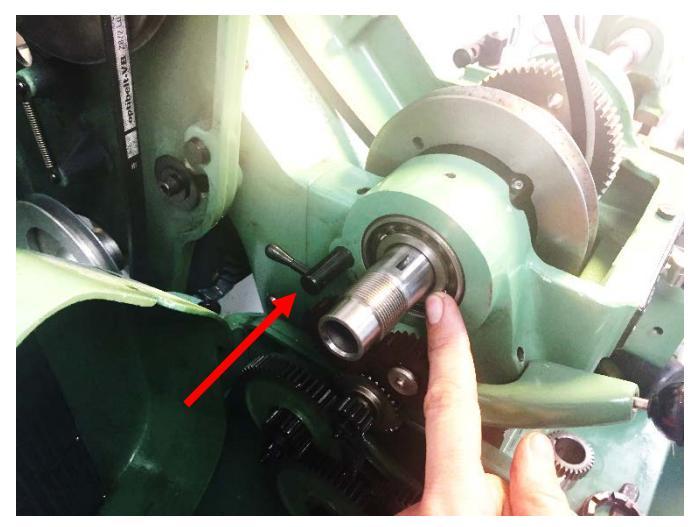
By further efforts for removal, I learned, that a further increasing of the torque would not be the solution as already now I can observe the limits of the spindle locking capability of the metal bolt that the Super7 provides for this purpose! The force introduced by me and the metal wrenches to the chuck was so big, that I even could observe a slight slip of the locking mechanism!

So a "brainless" increase of the loosening torque would not solve my problem, but surely damage my lathe by warping the spindle or cracking the locking mechanism! I need to find another solution!

Figure 10: spindle lock mechanism of the Super7 (photo taken during bearings replacement)

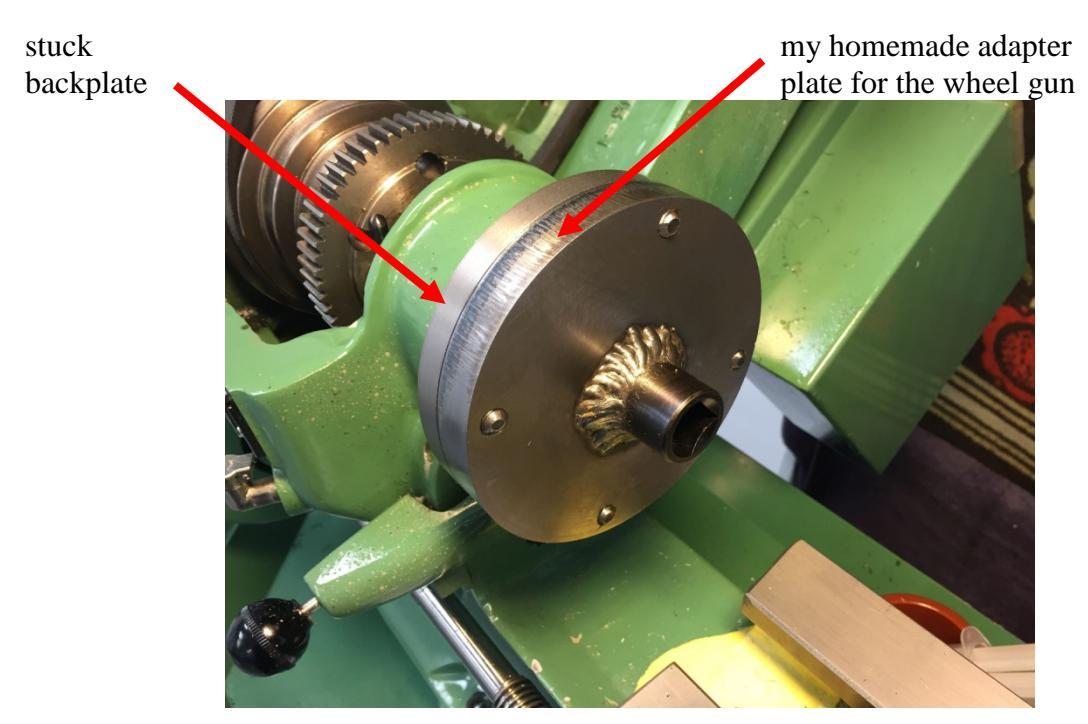
Figure 21: adapter successfully screwed to the stuck backplate...

The next step was, to machine an adapter plate for this backplate that I can use for my wheel gun. For that, I need to drill 4 holes, tap them with an M8 winding, then cut a relief area so that this adapter plate will completely match to the backplate. A 1/2" nut for the wheel gun will afterwards be iron welded to the center of the adapter plate.

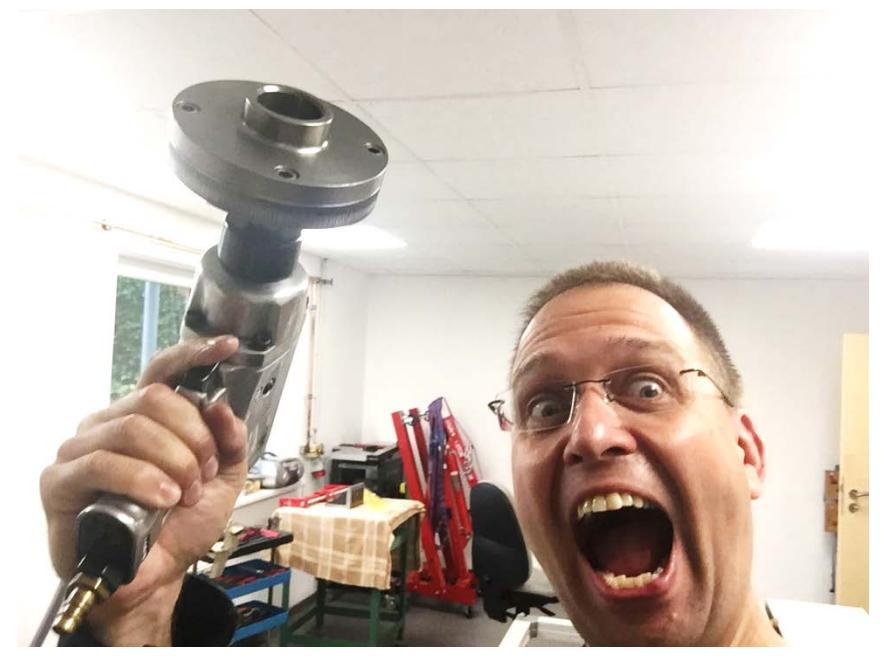
Figure 24: got it!!!!

Although the Baby Boa strip got a few scratches and dents, it holded -as Steven promisedsuccessfully the bullgear in place, without any damage or stress for the lathe. I removed everything and inspected the thread of the spindle. Luckily I always use plenty of oil on the thread before mounting any chuck, so I did in this case. So it probably helped to avoid "overtight damages" by reducing the friction. In the end I cannot find any signs of damage or unusual wear on the spindle's thread. That is good!

So I tightened the 4 screws, loaded the air compressor system with 10bar, put the air gun into it and- TACK TACK TACK-

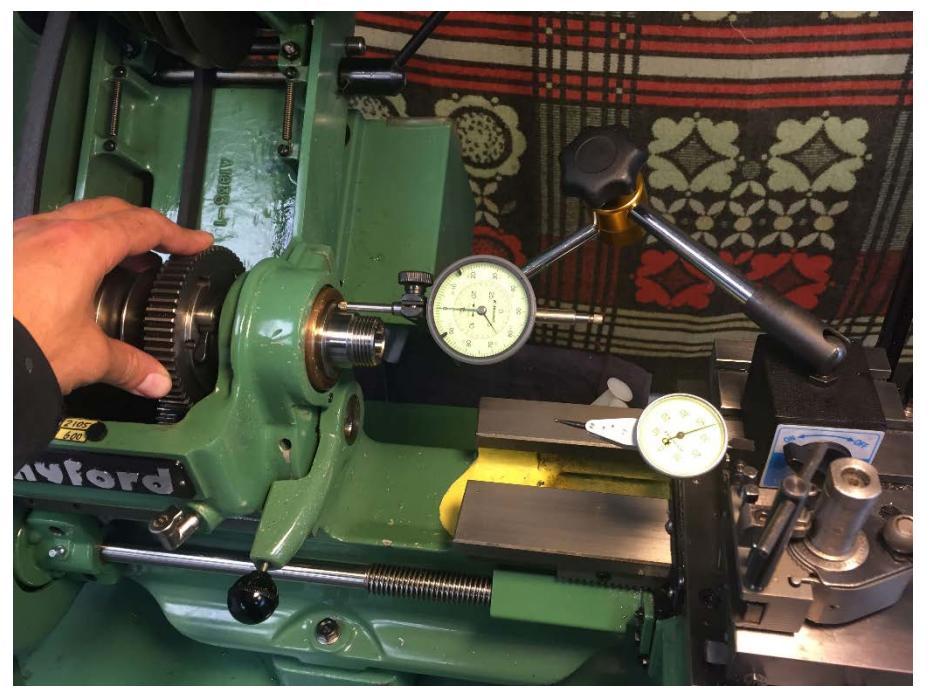
Figure 26: check the mandrel's runout...

The crash definately had introduced very heavy forces into the spindle's bearings, so I was really concerned as I put the dial indicator to it the first time. But after a few tests it looked like that the runout is still <10 μ m, so as before. I tested it on all three reference surfaces and also applied some slight force on it while measuring. Result: all still seems to be ok and fairly true. This is the next very good message.

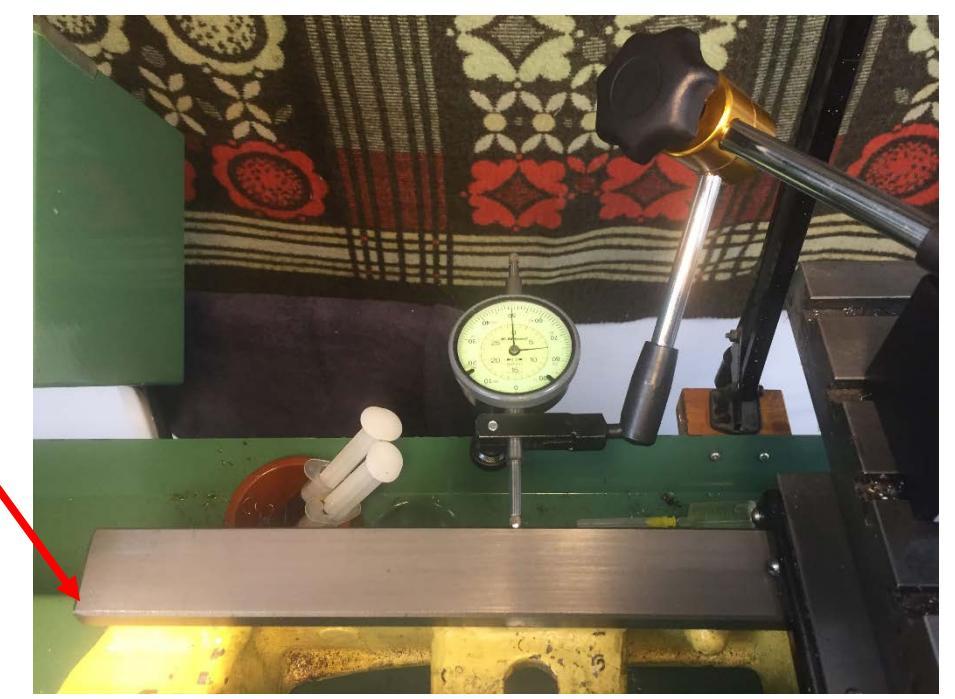
small dent (hard to see)

Finally I suspected the bedways to be damaged due to the crash. As I have not such a big reference plate (or straight edge) to put it on to*, I decided to use the only "second best" method the check. I installed the dial indicator on the cross slide and checked the shears by slowly measuring along them by moving the main slide. I know, that in this case you cannot believe this measurement 100%, because your reference is following somehow the (maybe) damaged shears, but I cannot see any other possibility for me. And for this, I get another good result: also the shears seem to be still very good in shape- no signs of any twisting or warping because of the crash. So the only effect of my crash on the bedways is only the small dent at its farest end**. What a luck! I am completely happy!

Figure 28: Did the bedways get some damage?

** It was not, but as I will discover later, the crash has disaligned the complete headstock a bit towards the user. According to my tests it is only 50μ m over a distance of 100mm, but that's pretty much deviation if you try to turn a 30mm long bronze bearing matching to H7/h7 standard. I will get this corrected, but not within this report.

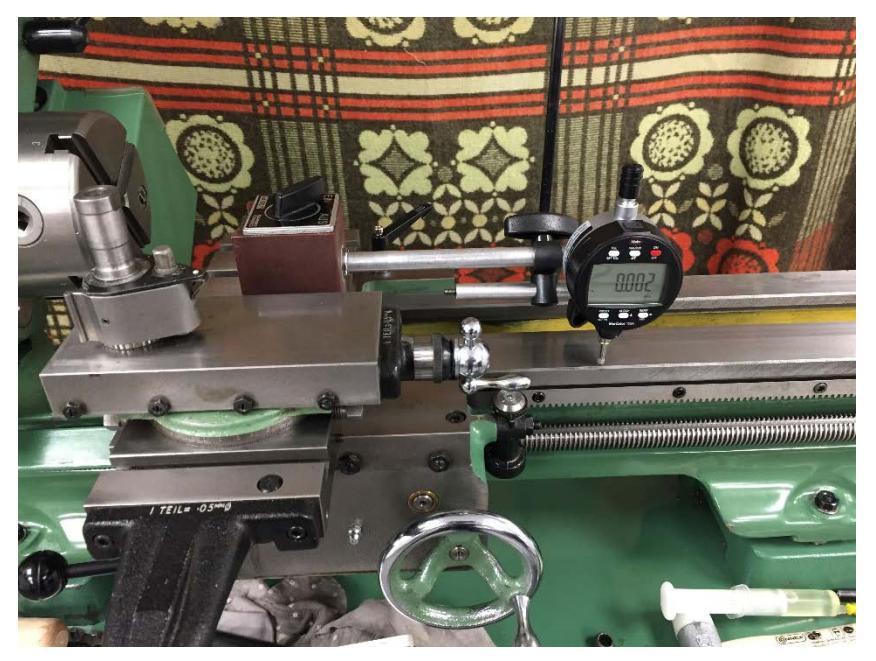
Figure 29: Does not seem so. All looks still good.

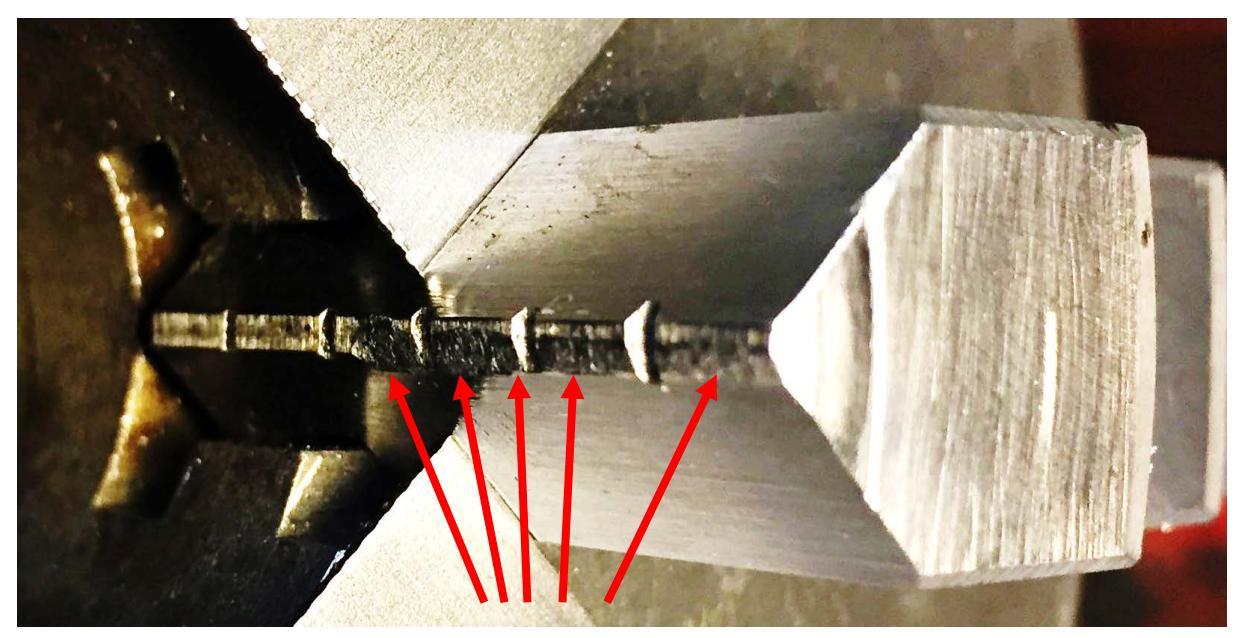
Finally I can declare the lathe as "healthy" step by step. Or at least as "not seriously injured". It looks like the only thing that I actually need to correct is the surface of the jaws, that I ruined with my hexagon nut and the car wheel gun. But also in this case it is probably repairable: as the jaw sides itself and also its slots seem to be undamaged, a good grind of its mating surfaces will be sufficient. And at last it would be advisable to do this anyway as this chuck was not new as I got it together with the lathe.

Figure 30: one of the jaws- look's pretty bad and deformed, isn't it..?

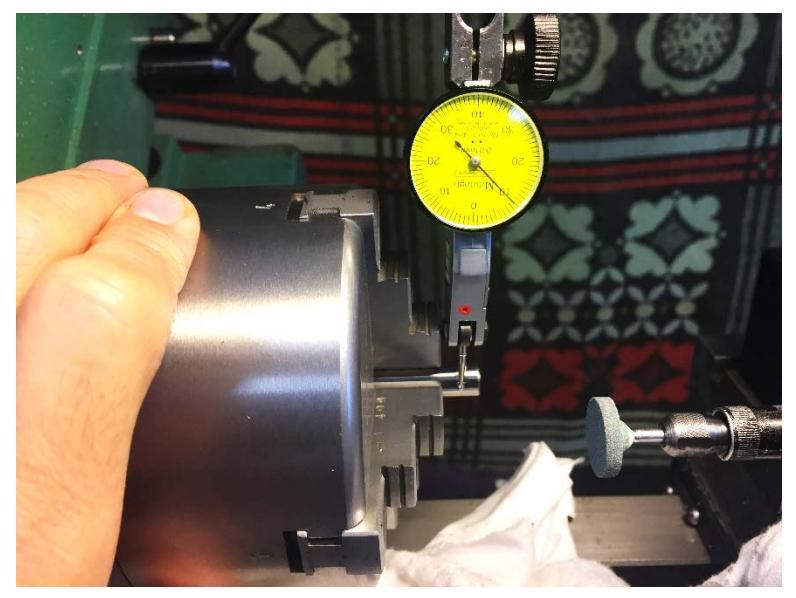
Figure 34: checking the runout before grinding

Position	runout (Total Indicator Reading)
0°	60 µm
90°	30 µm
180°	25 μm
270°	90 μm

So according to this test, I thought that it would be the best, to assemble the chuck in the 180° position to the backplate, as this shows obviously the smallest runout. But after having assembled the chuck again to the 180° position, I was not able to reproduce this 25μ m runout! So what happens here?

I investigate the screws and detect, that they all have a different diameter of their heads as well as the length of their threads. This still comes from the pre-owner of this lathe who obviously thought, that it would have no effect on the end result. But it has and Steve and Stefan both show us the procedure how to align a workpiece by half-loosening the backplate screws and tipping the chuck into position!

- 1. Turn the head of the screws to ONE common diameter
- 2. Shorten the screws to ONE common length
- 3. Turn the surface of the chuck backplate nicely flat and square

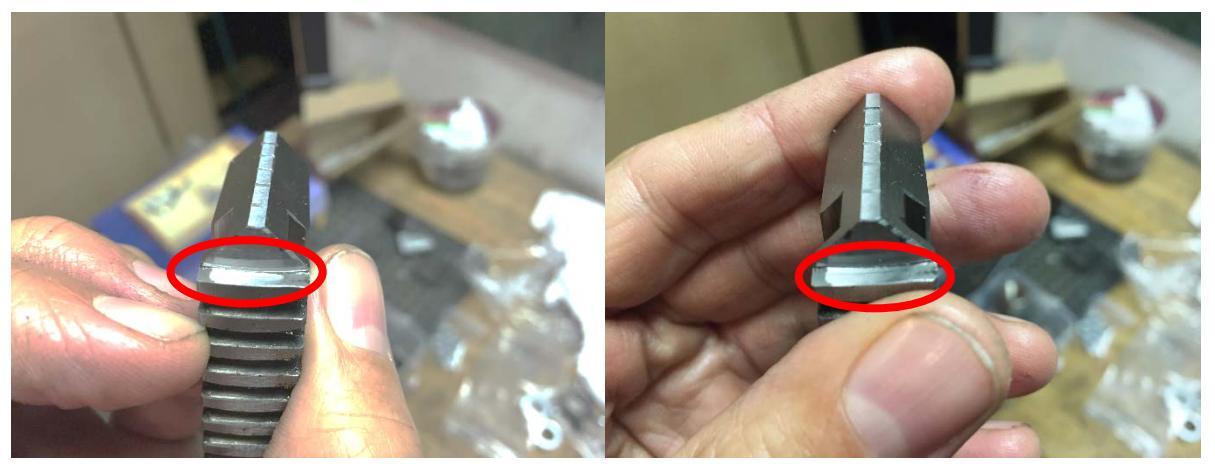
Just to verify, I use the second set of jaws, that I have for this chuck. Those are "inverted" jaws that are preferred when clamping workpieces not from outside, but for inside. For this tests, it probably does not matter. But <u>what</u> matters is the fact, that this set of jaws was obviously not as much used as the standard set and thus has not that much signs of wear. So it is not a surprise that with this set I get a slightly better runout values. But there are still the signs of wear inside this chuck that I cannot ignore.

Figure 40: quite a lot of wear in the jaws...not helpful for a small runout
