Repair report: Microphone of Sennheiser MD 441

Translation from German to English provided by David Every, Sydney, Australia in June 2018

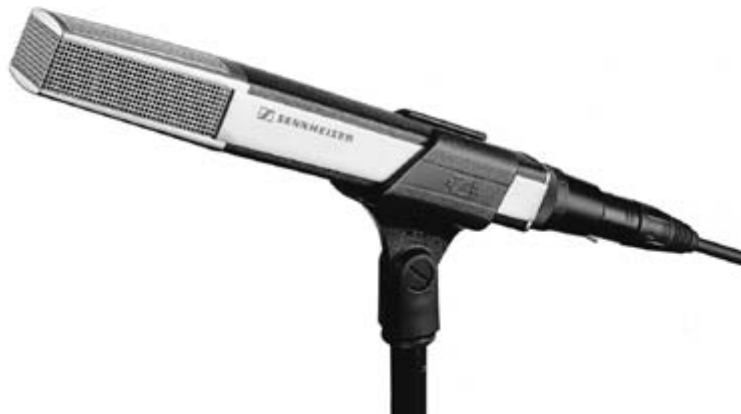
Figure 1: Sennheiser MD-441 (Source: www.sennheiser.com)

The microphone, which I now have on the bench, shows the following problem: when I carefully move the microphone back and forth - it makes a noise on the inside like a child's rattle. Surprisingly, you still get audio from the microphone if you speak into it.

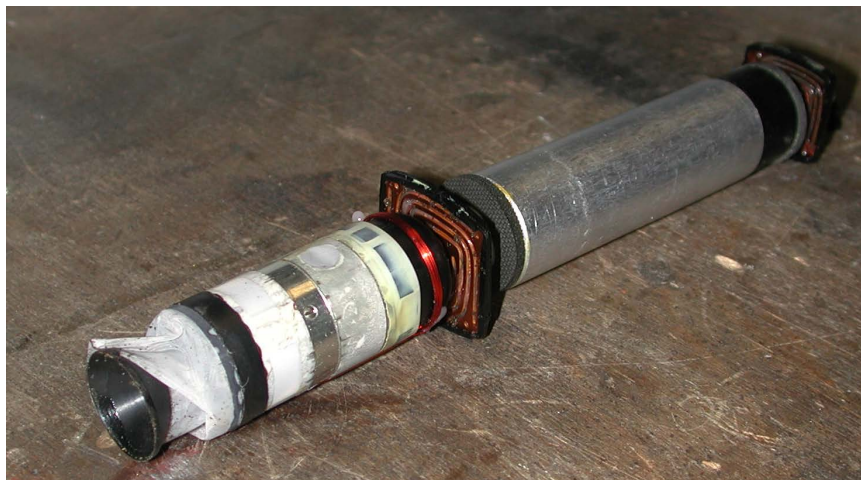
Figure 7: Inner workings (cone is on the left)

Of course, I want to first try to mend the bond. To do this, I pull out the complete interior upwards (the two vibrating elements together). The microphone body is only loosely connected, I remove it and put it on the bench. The original fixing seems to be a kind of silicone adhesive, so I opt for repair for silicone rubber from the tube (ELASTOSIL).

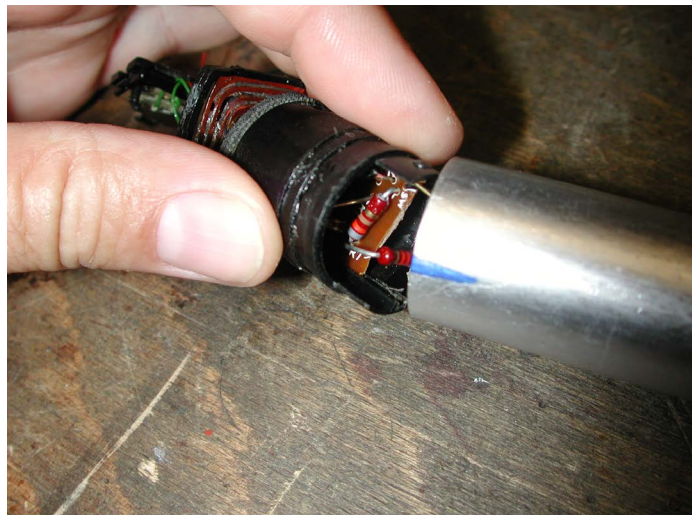
Figure 11: Cap is off - but the resistor also ;-)

I was promptly greeted with a broken circuit board inside the metal drum No. 2; the other half was caught in the just-removed cap. I twiddled both parts out and eyed the damage. The circuit board is a passive crossover; 1 layer PCB with normal wired components fitted. So, basically it should be possible to repair with some home remedies only.

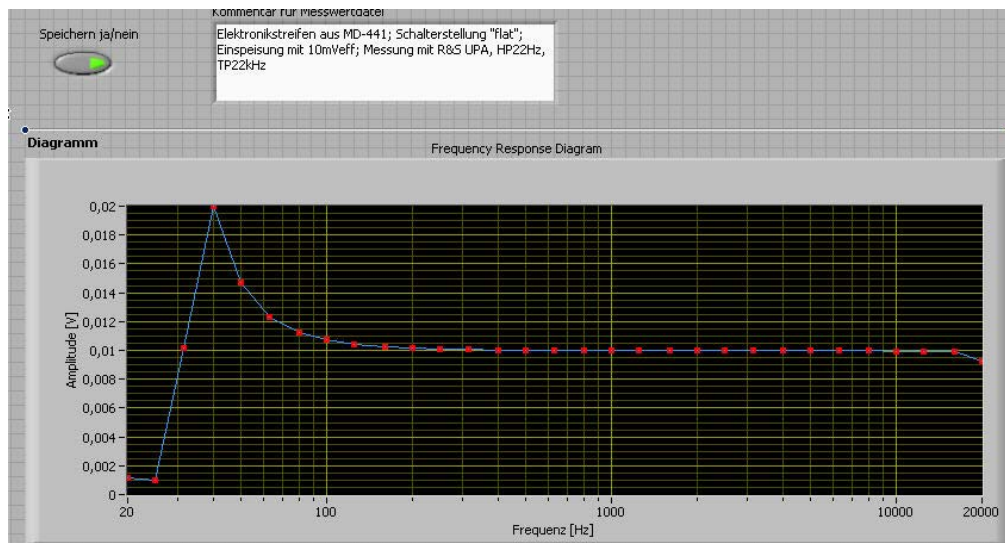
Figure 17: "flat" position frequency response

Ha! Sennheiser adds an increase in the bass range at around 40 Hz! Right there, where a Bass (Kick) Drum typically has its "oomph" (some do not know for sure, the "Kick" itself however is about 4-5kHz!) and where the most PA systems normally have their lowest cutoff frequency. Smart, smart!

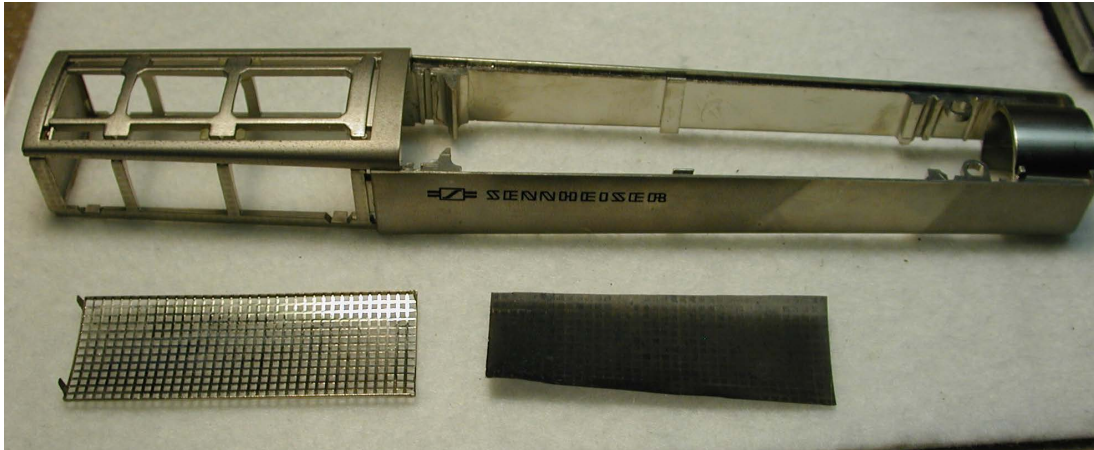
Figure 19: MD-441 frame and speech input basket with metal gauze

Just inside, the bent lugs can be bent up. Then the metal grille including the underneath dark strip of the filter can be removed. The tinsel seems to exist probably as a very fine metal mesh (gauze), another type of wind or pop shield. We can now ensure that the the metal gauze can be cleaned but make sure not to overbend it or make dents inside! I have cleaned as follows:

1. A dip in an ultrasonic bath (20 min, 60 ° C)
2. cotton swab with Kontakt60 (cleaning spray, provided by manufacturer "Kontakt Chemie")
3. liquid detergent with toothbrush

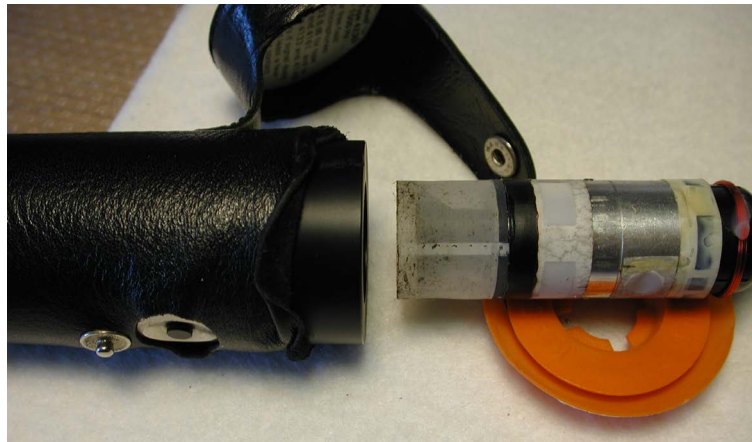
Figure 29: Sound calibrator with 94dB(A) on the microphone capsule

As a precaution, I will check the correct function of the electroacoustic transducer before final assembly. Its cone has a diameter of slightly less than 1 inch so I dug my Sound Calibrator off the shelf and generate a precisely defined 94dB(A) signal with sound pressure level at $f = 1$ kHz.

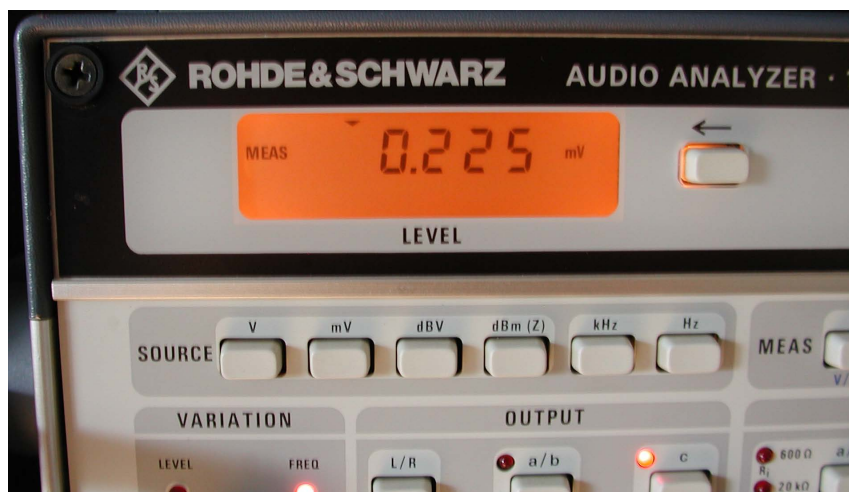
Figure 30: output voltage of the electroacoustic transducer with 94dB(A) into the speech input basket

At the exit of the electroacoustic transducer (measured using high impedance) I can read about a good $500\mu\text{V}$. That's probably fine for a MD-441, because two other MD-441 showed similar values. By the way: if I put the 94dB directly into the microphone speech input basket of a correctly assembled MD-441, I measure something between $200\mu\text{V}$ and $300\mu\text{V}$. Conclusion: Reading is at least plausible; the transducer seems to be still ok. Thus we now dare to move to the Final Assembly.

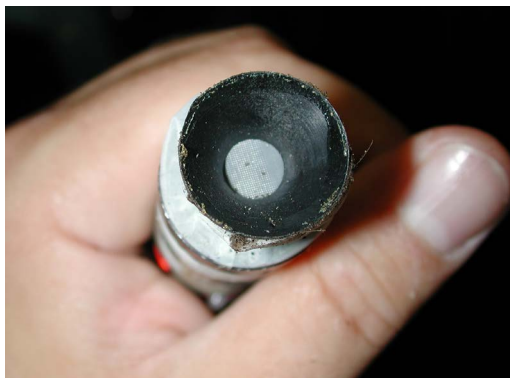
Figure 37: cone with foam remains on the edge

I then placed the microphone unit vertically and look into the naked cone. The crumbled foam unfortunately left ugly, sticky crumbs. Without a shower in the bathroom sink, it will be difficult to remove.

I can say I will definitely not go for this kind of wet cleaning for such a sensitive transducer. I therefore prefer to reduce my cleaning to the use of forceps or a vacuum cleaner set on lowest level with a special “frontend” which is like a mini hosepipe with only 1cm diameter, to remove (only) the crumbs that lie directly in the cone. All other crumbs in the environment I will stick with, because the risk is too great that, through the clean-up, we may cause the microphone capsule harm.

Since I don't know how my 5-minute epoxy responds to foam, I use my silicone rubber ELASTOSIL. Also, I am quite aware that the adhesion to the present plastic is lower than with the epoxy: the acoustic foam is light as a feather, the bond is not as strong as it claims. For this, I think the need of flexibility is far more important. So, I put on the edge a thin bead of silicone rubber and put the acoustic foam hemisphere in the funnel. Very gently, allow to harden then leave it alone for a while to set.
