Bird 4311 Thruline Wattmeter

Welcome onboard this restauration report of a Bird 43 RF wattmeter!

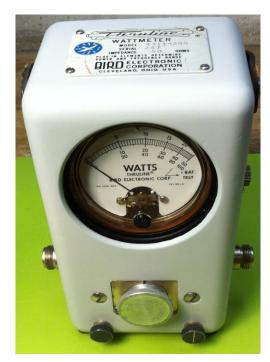
figure 1: my Bird4311 Thruline wattmeter

I got this Bird 43 (precisely: Bird 4311-200) as part of a bequest from a good friend of mine. He was radio amateur and one of the founder of our german INTERRADIO amateur radio exhibition in Hannover (germany). Before he passed away a while ago, he gave me this unit for our INTERRADIO RF test station and we used it for many years without any problems.

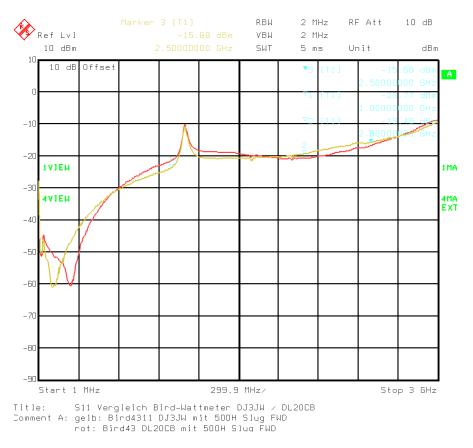
figure 4: S11 comparison with 500W slug

In figure 4 you can see the matching parameter (S11) of my Bird4311 and the one from my friend. During this test, the 500watts power slug (500H) was used; forward position.

I guess anybody can easily see, that both curves in the diagram are absolutely comparable. So no problems here. Also with a smaller 5watts slug (5E), see figure 5.

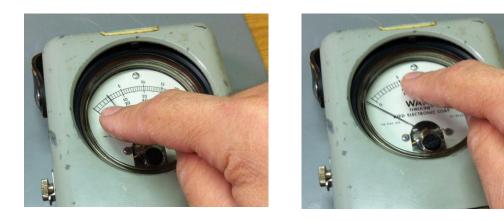
figure 6: distracting the needle just by finger moevement!

In order to search the reason for the displayed error, I observed that tipping the meter with the finger changes the measured value quite a lot! Also the reproduceability of the readings was not as good as with the newer 4304-400 one from my friend. After some tests, I am quite sure, that the needle mechanically touches the scale (or magnet) somewhere that caused it getting stuck somewhere on the way to the "correct" needle position.

Furthermore the finger-tipping showed another effect that especially the electronic newcomers may not know: electrostatics!

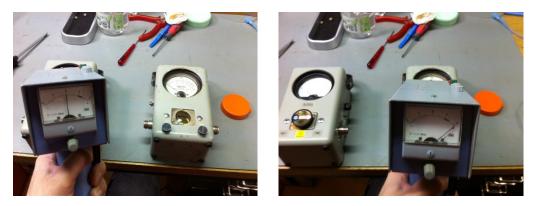
figure 8: 0kV on the left Bird; more than 20kV on the right one!

My old Bird caused readings of up to 20kV/m whereas the new Bird of my fried behaved completely different: no significant fields can be measured here!

For me, this is the evidence for having definately a problem with electrostatic effects!

Sure, this can easily cause misreadings that could explain the observed measurement error.

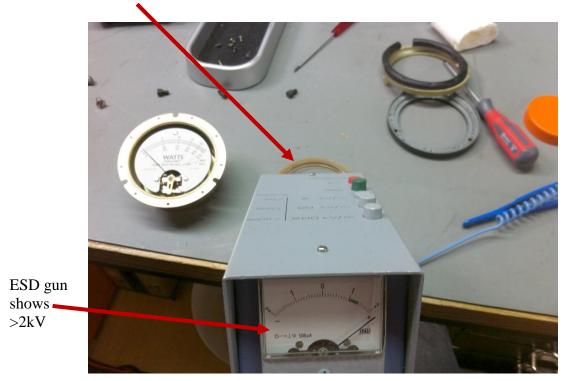
figure 13: examinating the meters's front cover

Then the electrostatic problem: the electrostatic effect. This was still reproducible and the plastic glass of the display turned out to be the main "charge collector".

plastic cover of the meter under test

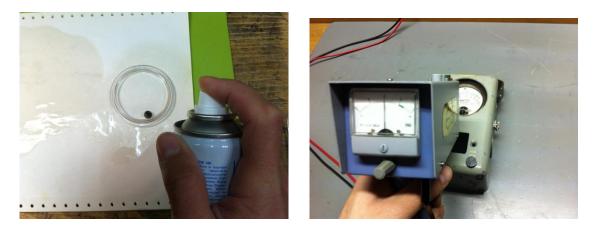
figure 15: ESD problems are gone after spraying the meter's glass with Antistatik 100!

Then the surprise: like with the new Bird4304 of my friend, the ESD gun could not detect any ESD charge any more on my sprayed Bird4311 meter! Electrostatic effects were completely gone! Great!!!!

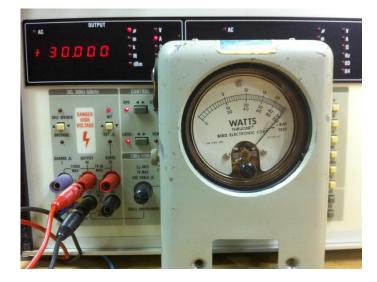
figure 16: meter check with DC calibrator

Encouraged by this great success, I made a final check using my DC current calibrator. The meter is supposed to be a 30μ A full-scale meter and -indeed- the needle reached its full-scale at a current of exactly 29,6 μ A- this is about 2% error only! Again: great!

I made spot-checks at $0\mu A$ (= zero position), $30\mu A$ (=fullscale) and $15\mu A$ whereas the needle optically met the middle of the scale quite good. So this 3-spot-calibration is supposed to be enough to confirm, that the meter itself might be still usable.

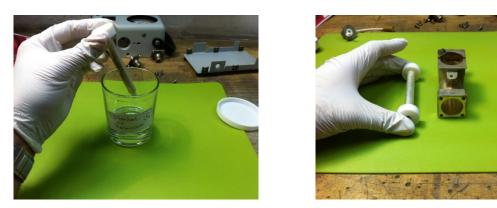
figure 21: using chemical silver cleaner for the RF path

My wife (who studied chemistry) told me that I have to take preventive safety actions, because this cleaner is supposed to cause cancer and also can damage your genetic code, so we have to take this serious. I wear plastic gloves and switch on the fume extractor that I have installed in my workshop.

I use a cleaner that was originally made for silver jewels (you can also consider the Bird43 to be a "jewel" somehow ;-)

Simple toilet paper is nicely suitable to deploy the silver cleaner to the thruline element parts. Wipe it softly and observe how the surface gets smooth and shiny again. Don't forget to remove all of the residual cleaner afterwards, because normally the guy who just wants to measure RF power, will *not* wear protective gloves ;-)

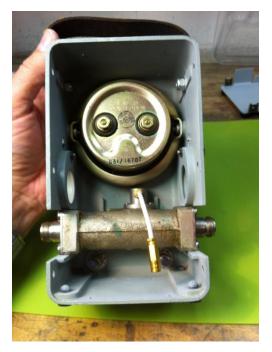
figure 24: Assembly

I continue with the assembly. The two switches (Battery check, PEP measurement) I can fixate using a long 13mm hexagon nut. The thruline element itself is locked by two big fat screws that are as solid as the rest of the Bird43. Now, the Bird looks quite complete already. But there is still something to come!

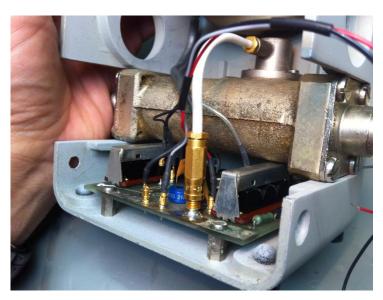
figure 25: the electronics for PEP measurement

Now comes a little bit of challenge: the electronics module! It is for PEP measurements; means PeakEnvelopePower. That feature is important for measuring the peak RF level value for double tone SSB or AM signals. Electrically it is probably something like a peak-envelope rectifier with a short attack, but a long release time. For this feature, the Bird43 needs an external power supply. And this is obviously defective in mine- first, one of the connecting cables is already broken and second, the battery back (NiCd accumulators?) is also defective. I count 15 cells in series- with assumed 1,2V/cell we have 18Volts in total. That does perfectly match to the picture of newer Bird PEP measurement kits which are using two 9V-Blocks as power supply (2X9V = 18V).

Because of the unusual shape factor of the internal NiCd accus, I decide to replace them by two ordinary 9V-Blocks- the same way like Bird did with their newer wattmeters.

But first I have to take care for the PCB itself. It is very dirty, so the first thing to do is to clean it with a brush and compressed air. Then I have to do something with the SMB jack, which is directly soldered onto the PCB. Don't ask me why, but the metal surface of this jack looks very "worn out". Normally this connector is plugged only *once* in the factory to connect the Slug's detector output to the PCB. But this one looks like somebody would have plugged it in and out a couple of hundreds of times. Cannot understand that.

Anyway, this connection has properly to by repaired, because any contact problem at this point results in an additional measurement error of the complete meter! So I simply replace the SMB jack by a new one and solder it briefly to the PCB.

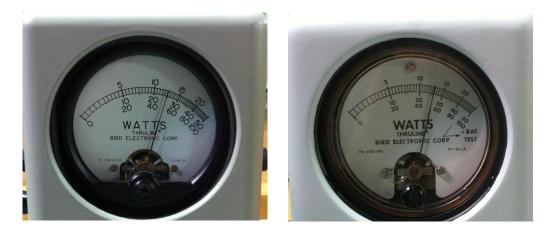
figure 30: ~ 5,4Watts shown on Bird 4304 (left) and my Bird 4311 (right)

In order to evaluate if my assumption is correct, I make several checks. First I compare the readings with the new Bird4304 of my friend. Here, the repeatability is much, much better. The needle stops every time at the same position- as I would expect it. Also my URV35 meter shows roughly the same values.

I swap the two Bird's in the RF signal flow order to exclude possible contact problems that could cause a non-stable RF reading. Result: no change. And this is additionally confirmed by the spectrum shown on the RF analyzer: the bad repeatability definately has something to do with the old Bird4311 itself.

In the last step I finally measure the DC voltage across the meter's connecting pins (to exclude a bad RF slug to deliver bad values). Result: the voltage across its pins is also almost the same, so there is only one thing left as root cause: the meter of the Bird4311 has too much friction for its easy needle movement! Oooouuuh... :-(((

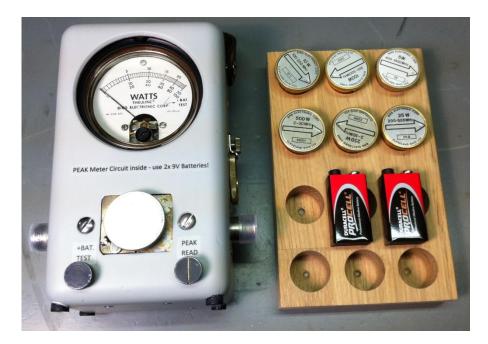
In the "winner photo" of the finished Bird4311-200, you may also see an additional text that I placed to its front. It shall remind the user not to forget to place batteries inside first before using the peak meter circuit! Normally the Bird has a set of internal NiCd-accus, charged by a 3,5mm jack in the side. As you can read above, I decided to replace them by two normal 9V batteries- like Bird also did in their newer instruments. So the "charge"-jack is now without function, as there is nothing to charge inside any more. I thought that this was worth a small notice on the front.

A selfmade, wooden slug holder completes my Bird powermeter project.
