Lathe crash: releasing a "stuck" chuck on a Myford Super 7

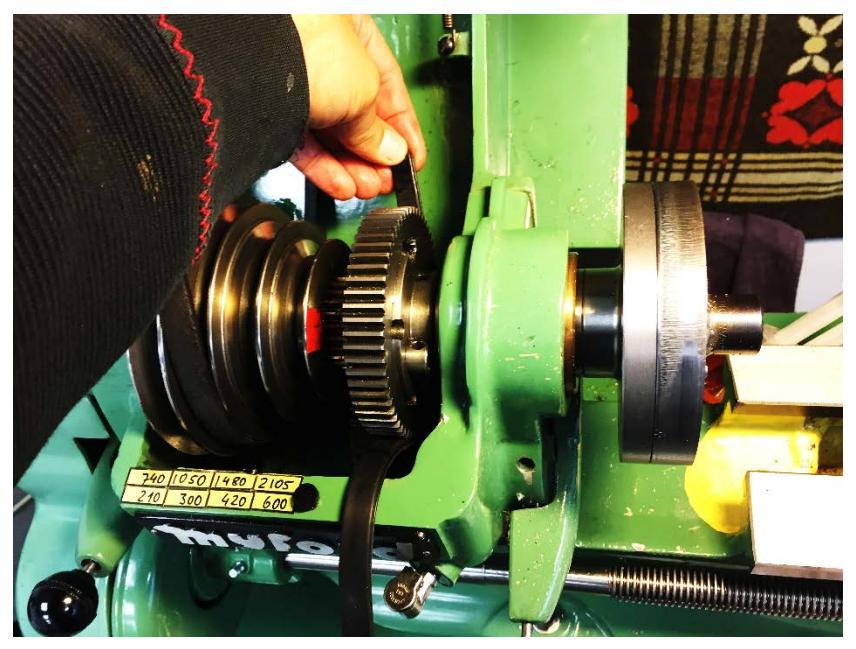
Figure 22: Baby Boa is in place....

First, I have ordered the "Baby Boa Strip" recommended by Steve. For about 9 Euros you get a grip and a rubber strip that you can place around the metal bull gear to lock the spindle instead of stressing the original locking mechanism. This strip helped me to fix the spindle without any damage on my lathe.

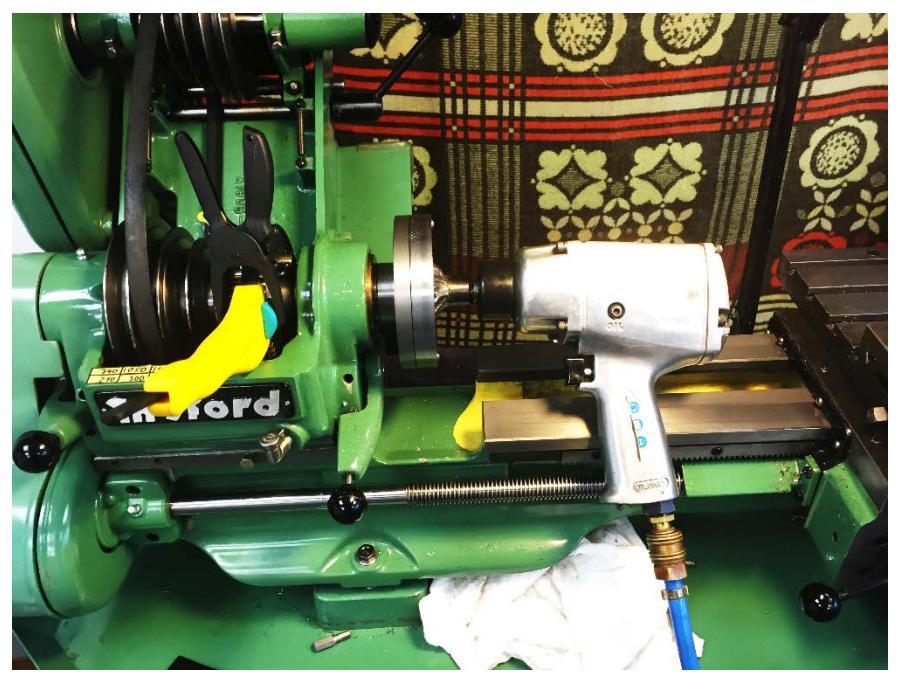
Figure 23: final setup with Baby boa and wheelgun

So I tightened the 4 screws, loaded the air compressor system with 10bar, put the air gun into it and- TACK TACK TACK-

...got the f.... backplate loose!! Yeahhh!!!

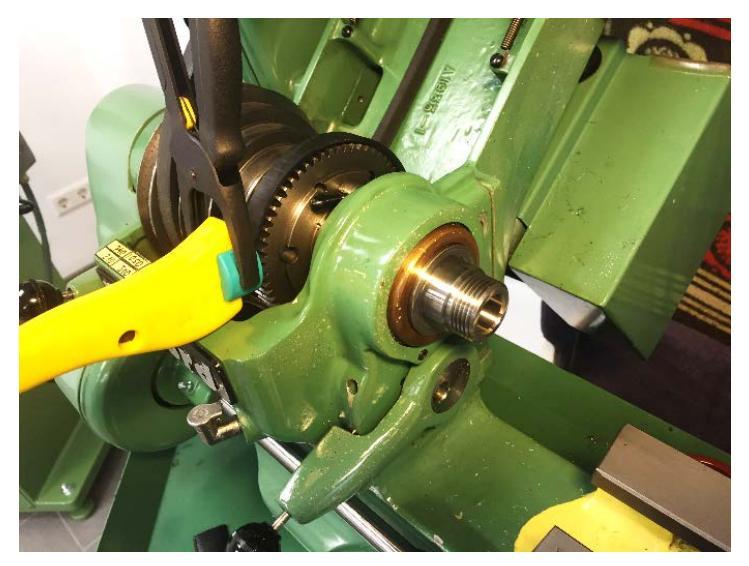
Although the Baby Boa strip got a few scratches and dents, it holded -as Steven promisedsuccessfully the bullgear in place, without any damage or stress for the lathe. I removed everything and inspected the thread of the spindle. Luckily I always use plenty of oil on the thread before mounting any chuck, so I did in this case. So it probably helped to avoid "overtight damages" by reducing the friction. In the end I cannot find any signs of damage or unusual wear on the spindle's thread. That is good!

Figure 25: the stuck chuck could finally be removed! Great!

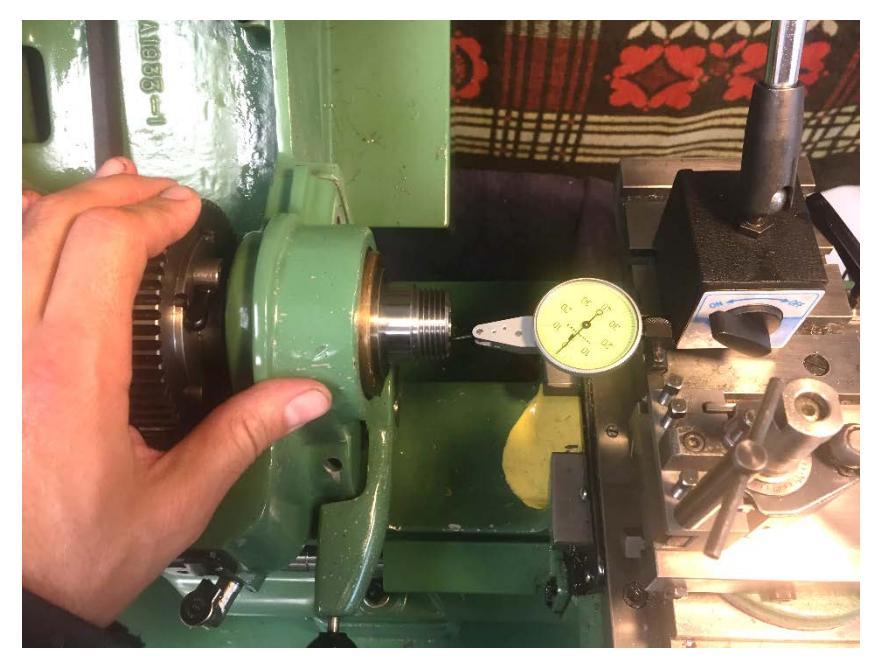
The crash definately had introduced very heavy forces into the spindle's bearings, so I was really concerned as I put the dial indicator to it the first time. But after a few tests it looked like that the runout is still <10 μ m, so as before. I tested it on all three reference surfaces and also applied some slight force on it while measuring. Result: all still seems to be ok and fairly true. This is the next very good message.

Figure 27:...on a few reference surfaces...

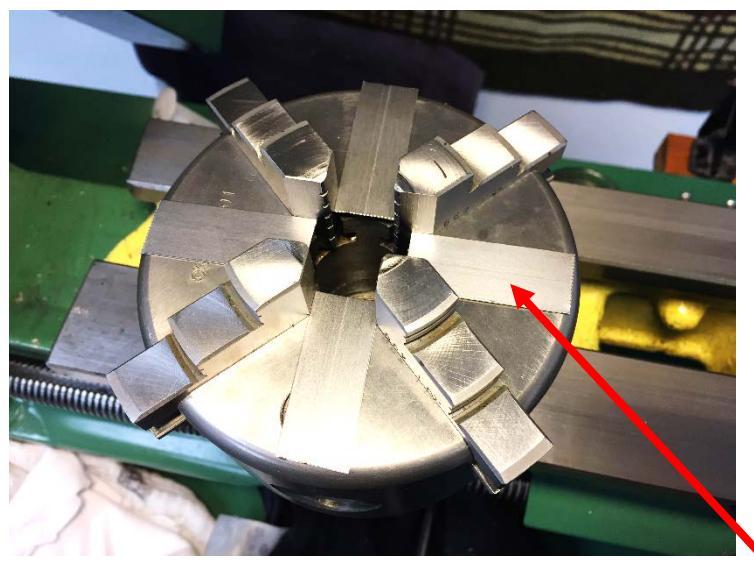
Figure 31: fnially I decided for another method for suitable preload

To prepare the grinding, we need to fix the jaws with a preload- like already described above. The plan was to use the hotglue gun, but then I had another idea. I was recently delivered a new big and heavy sized cupboad for the workshop. This was delivered on a wooden pallet, secured by a quite robust 12mm metal strip around it. Instead of throwing this metal strip away, I cut 4 short pieces out of it and clamp them between the 4 jaws. Then I close the chuck. The jaws now press the metal strips between each other- causing the desired preload (Figure 31!

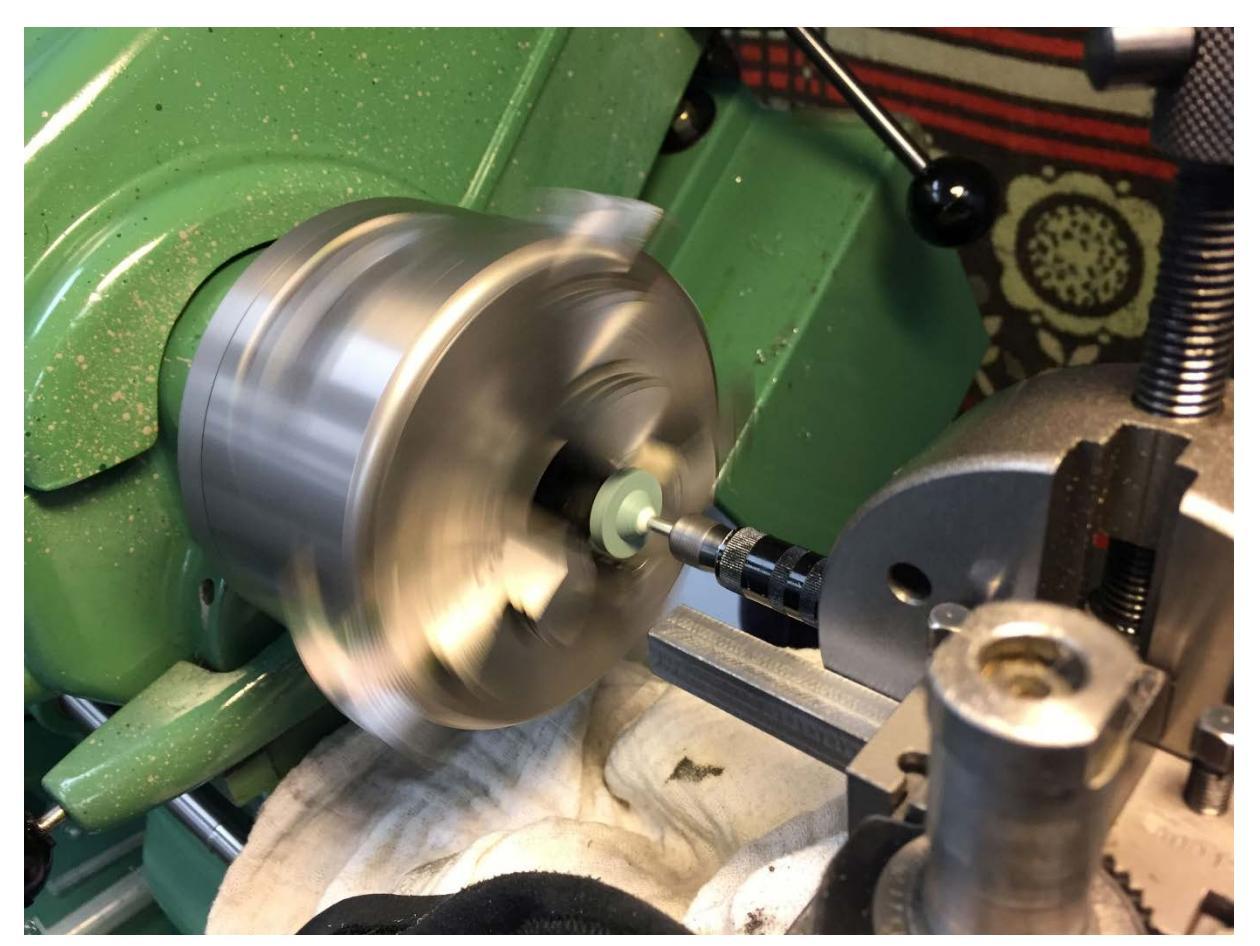
Figure 36: the grinding has begun!

As all looked good, I started the lathe with a speed of about 300rpm and the Dremel with its maximum speed. With a diamond tool I dressed the grinding disc very slightly. After this, I move the grinding wheel very, very slow into the opened "mouth" of the chuck. By using the cross slide, I detect the position, when the grinding disc just touches the highest points of the jaws. Then I add about 25μ m with the cross slide- causing the grinding disc to start the "real" grinding process. I am satisfied seeing the first sparks coming out of the chuck. After having driven the grinding support completely into the chuck (you need to do this very very slow, it can take about 5 minutes just for this few centimeters), I pull it out with the same slow speed.

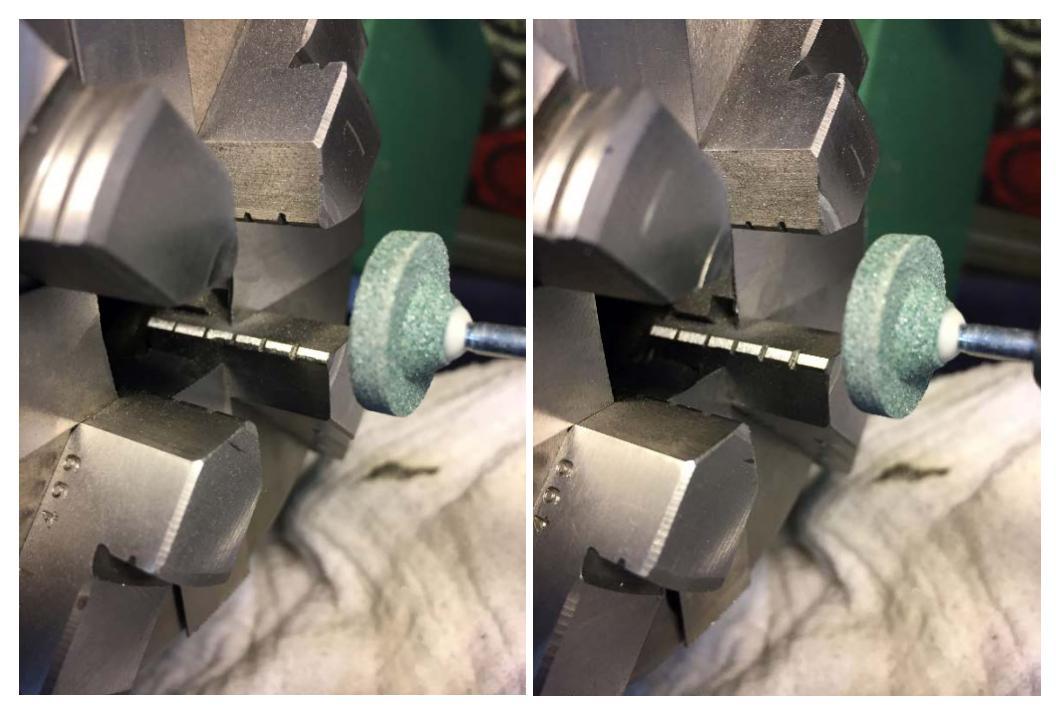
Figure 38: jaw's surface getting better- step by step

In the end it took me about 10 or 15 passes until the jaw grinding actually shows a flat area and no burr or deformed areas anymore. I am very very happy about the result, it really looks good to me!

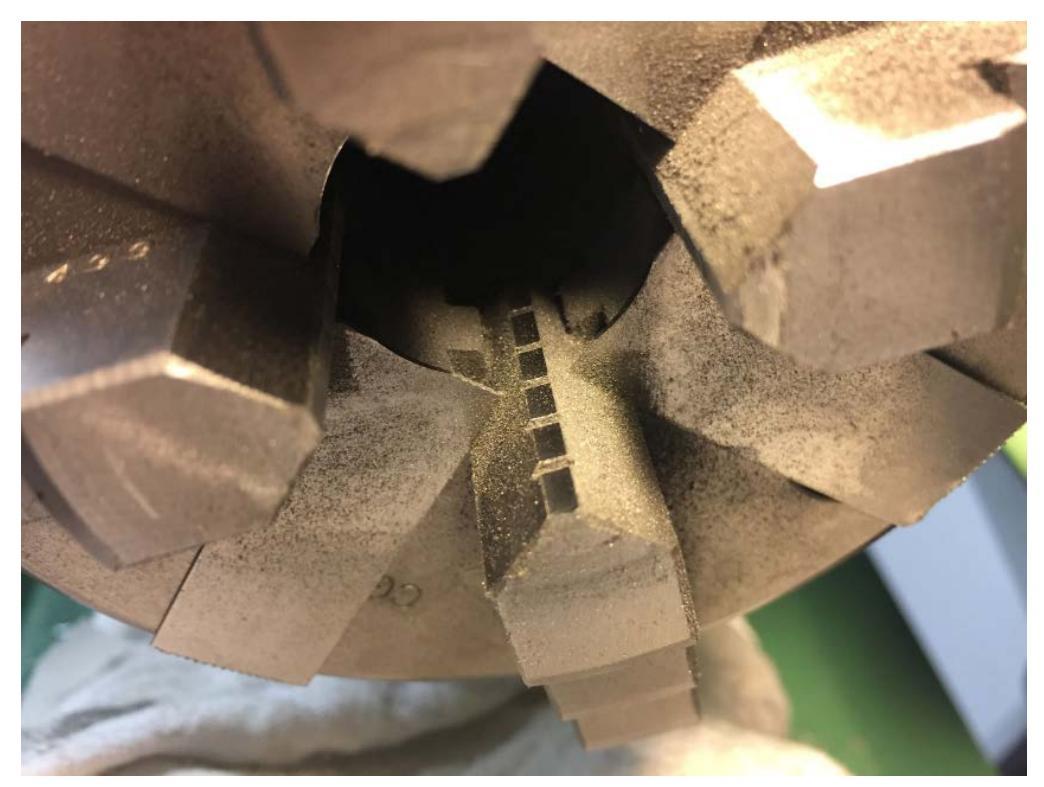
Figure 39: not bad- a quite smoothy looking finish!

I nevertheless think "success". The re-grinding of the 4 Jaws Chuck brought it at least from 200 μ m runout to 100 μ m TIR. Imperial thinkers would say "less than 4 thou". As result of the verification with the second set of jaws we could see, that probably the <u>massive wear at the rear of the jaws</u> is the reason for, that we are not able to improve the runout better than +/- 50 μ m- and not a maybe badly performed grinding process. This wear is something that we unfortunately cannot defeat, so at least we probably will have to live with it. But the good thing is: I again learned a lot during this refurbishment and thus I personally treat store this project in my brain as a "success". And what I must not forget: the provided clamping force of the chuck should have been improved a lot now, because the flat grinded contact surfaces will have much better contact to the workpiece than the warped surfaces before.

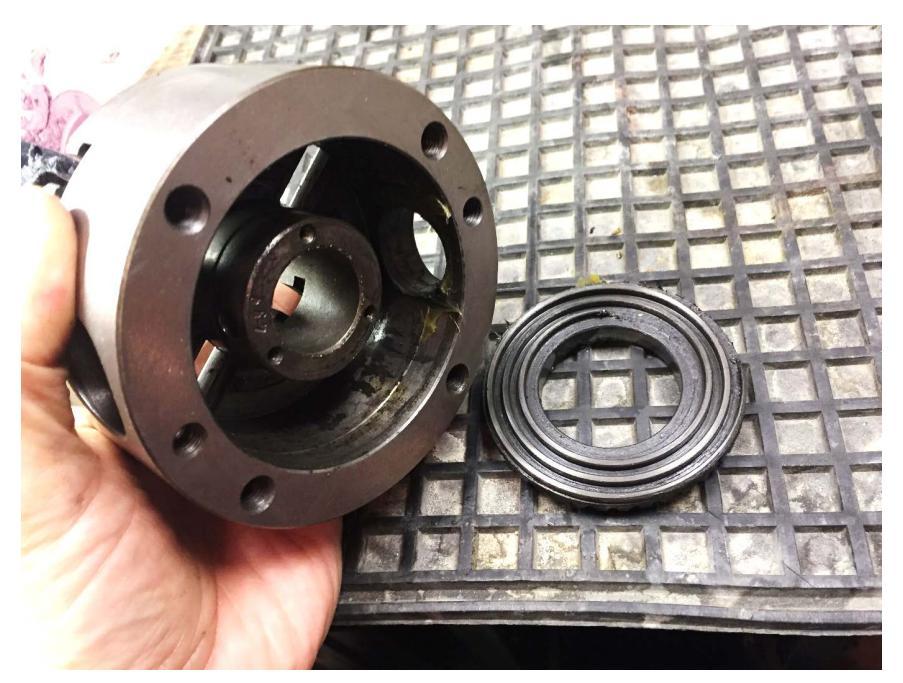
Their recommendation was to either ask Myford or the company "Klopfer" for replacement parts- depending on the original manufacturer of the chuck. As I have no clue who the original manufacturer was (no brand's name or other sticker on it), I did not follow up this topic. There is no evidence that it is <u>only</u> the jaws but could be the inner spiral of the chuck as well, so buying a new one is probably cheaper than purchasing expensive spare parts.

Figure 42: the inner spiral of this chuck (see right)
